Ground Water Investigation

Hay Water Supply System

Summary report

Report Number: P-FY20242939-PWO-WTA-RP-001-01

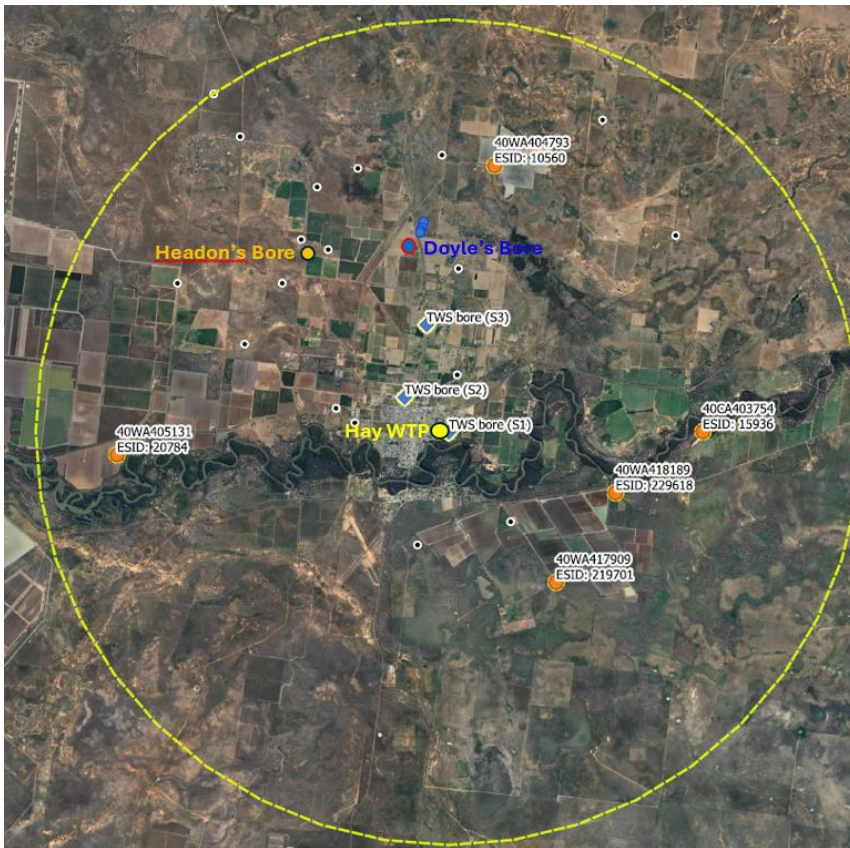
The existing bores, including Doyle's Bore (100–120 m deep) and Headon's Bore (approximately 250 m deep), which were used for testing, are considered relatively shallow. According to the hydrogeologist's report, the bores need to be drilled deeper to reach the next aquifer, which may yield better-quality water. Details on test bore drilling are provided in the hydrogeological report.

It is recommended drilling a new test bore into the next layer aquifer at an appropriate location within the identified area shown with the dotted line on the below map.
